Master of Arts SUPSI in Conservation-Restoration

# Blackening of lead-based pigments in wall paintings: Reconversion and stabilisation.

The painted ceiling of Castello Trefogli at Torricella (TI-CH).

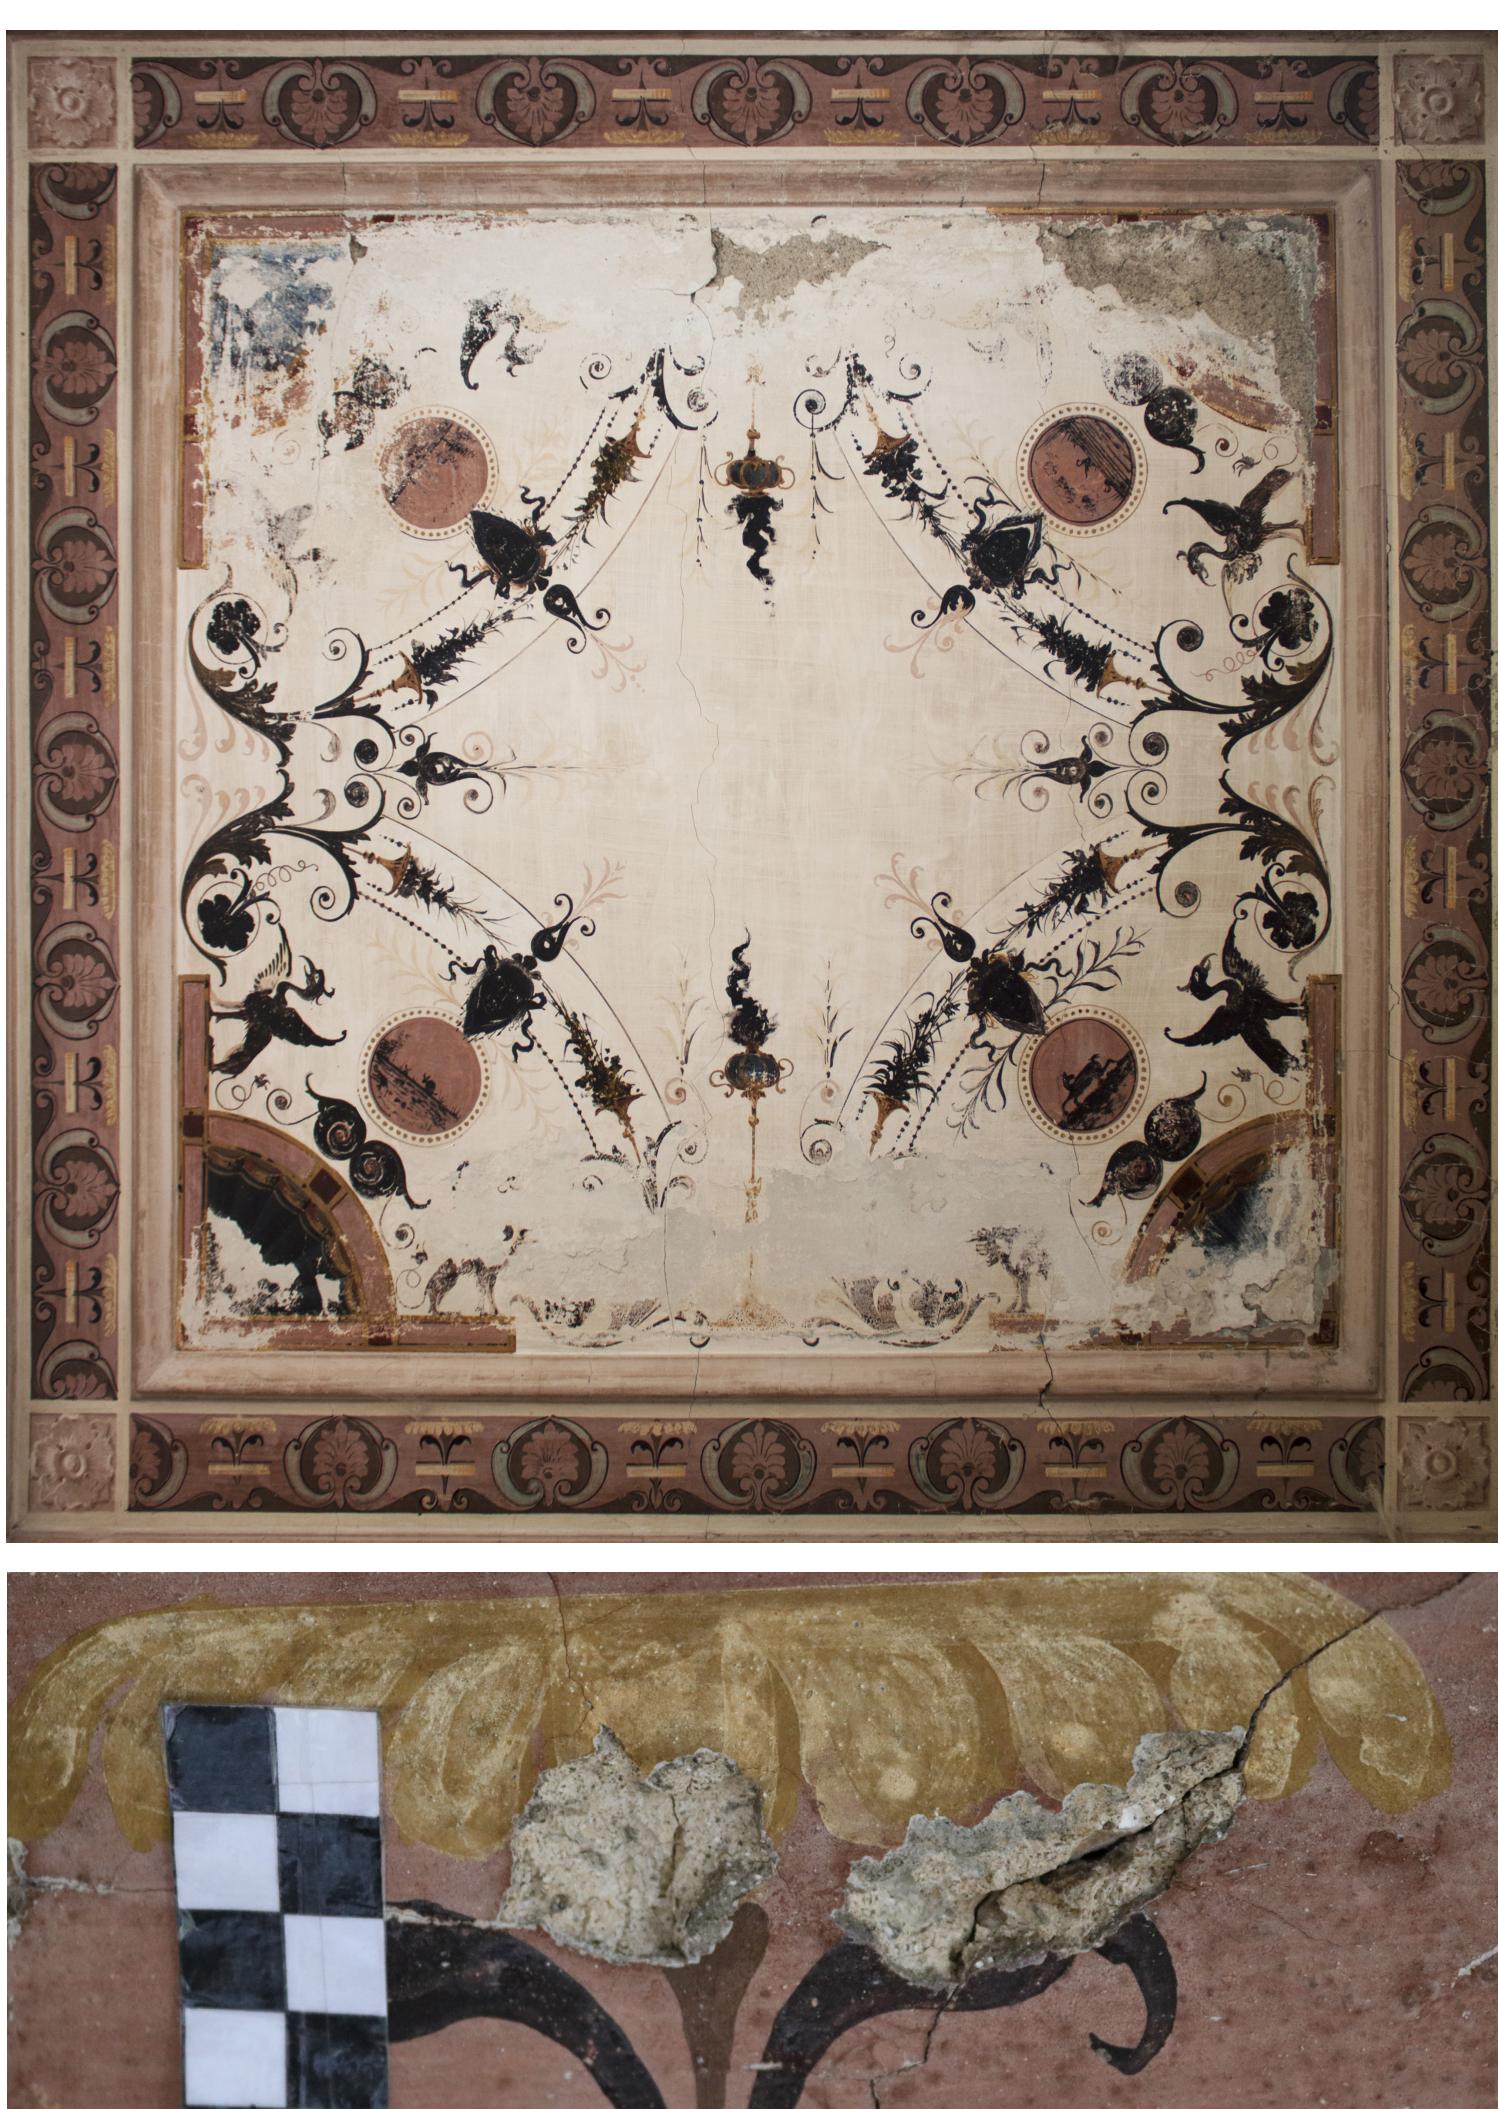
Fig. 1 : The Painting of the North Tower and detail before the interventions.

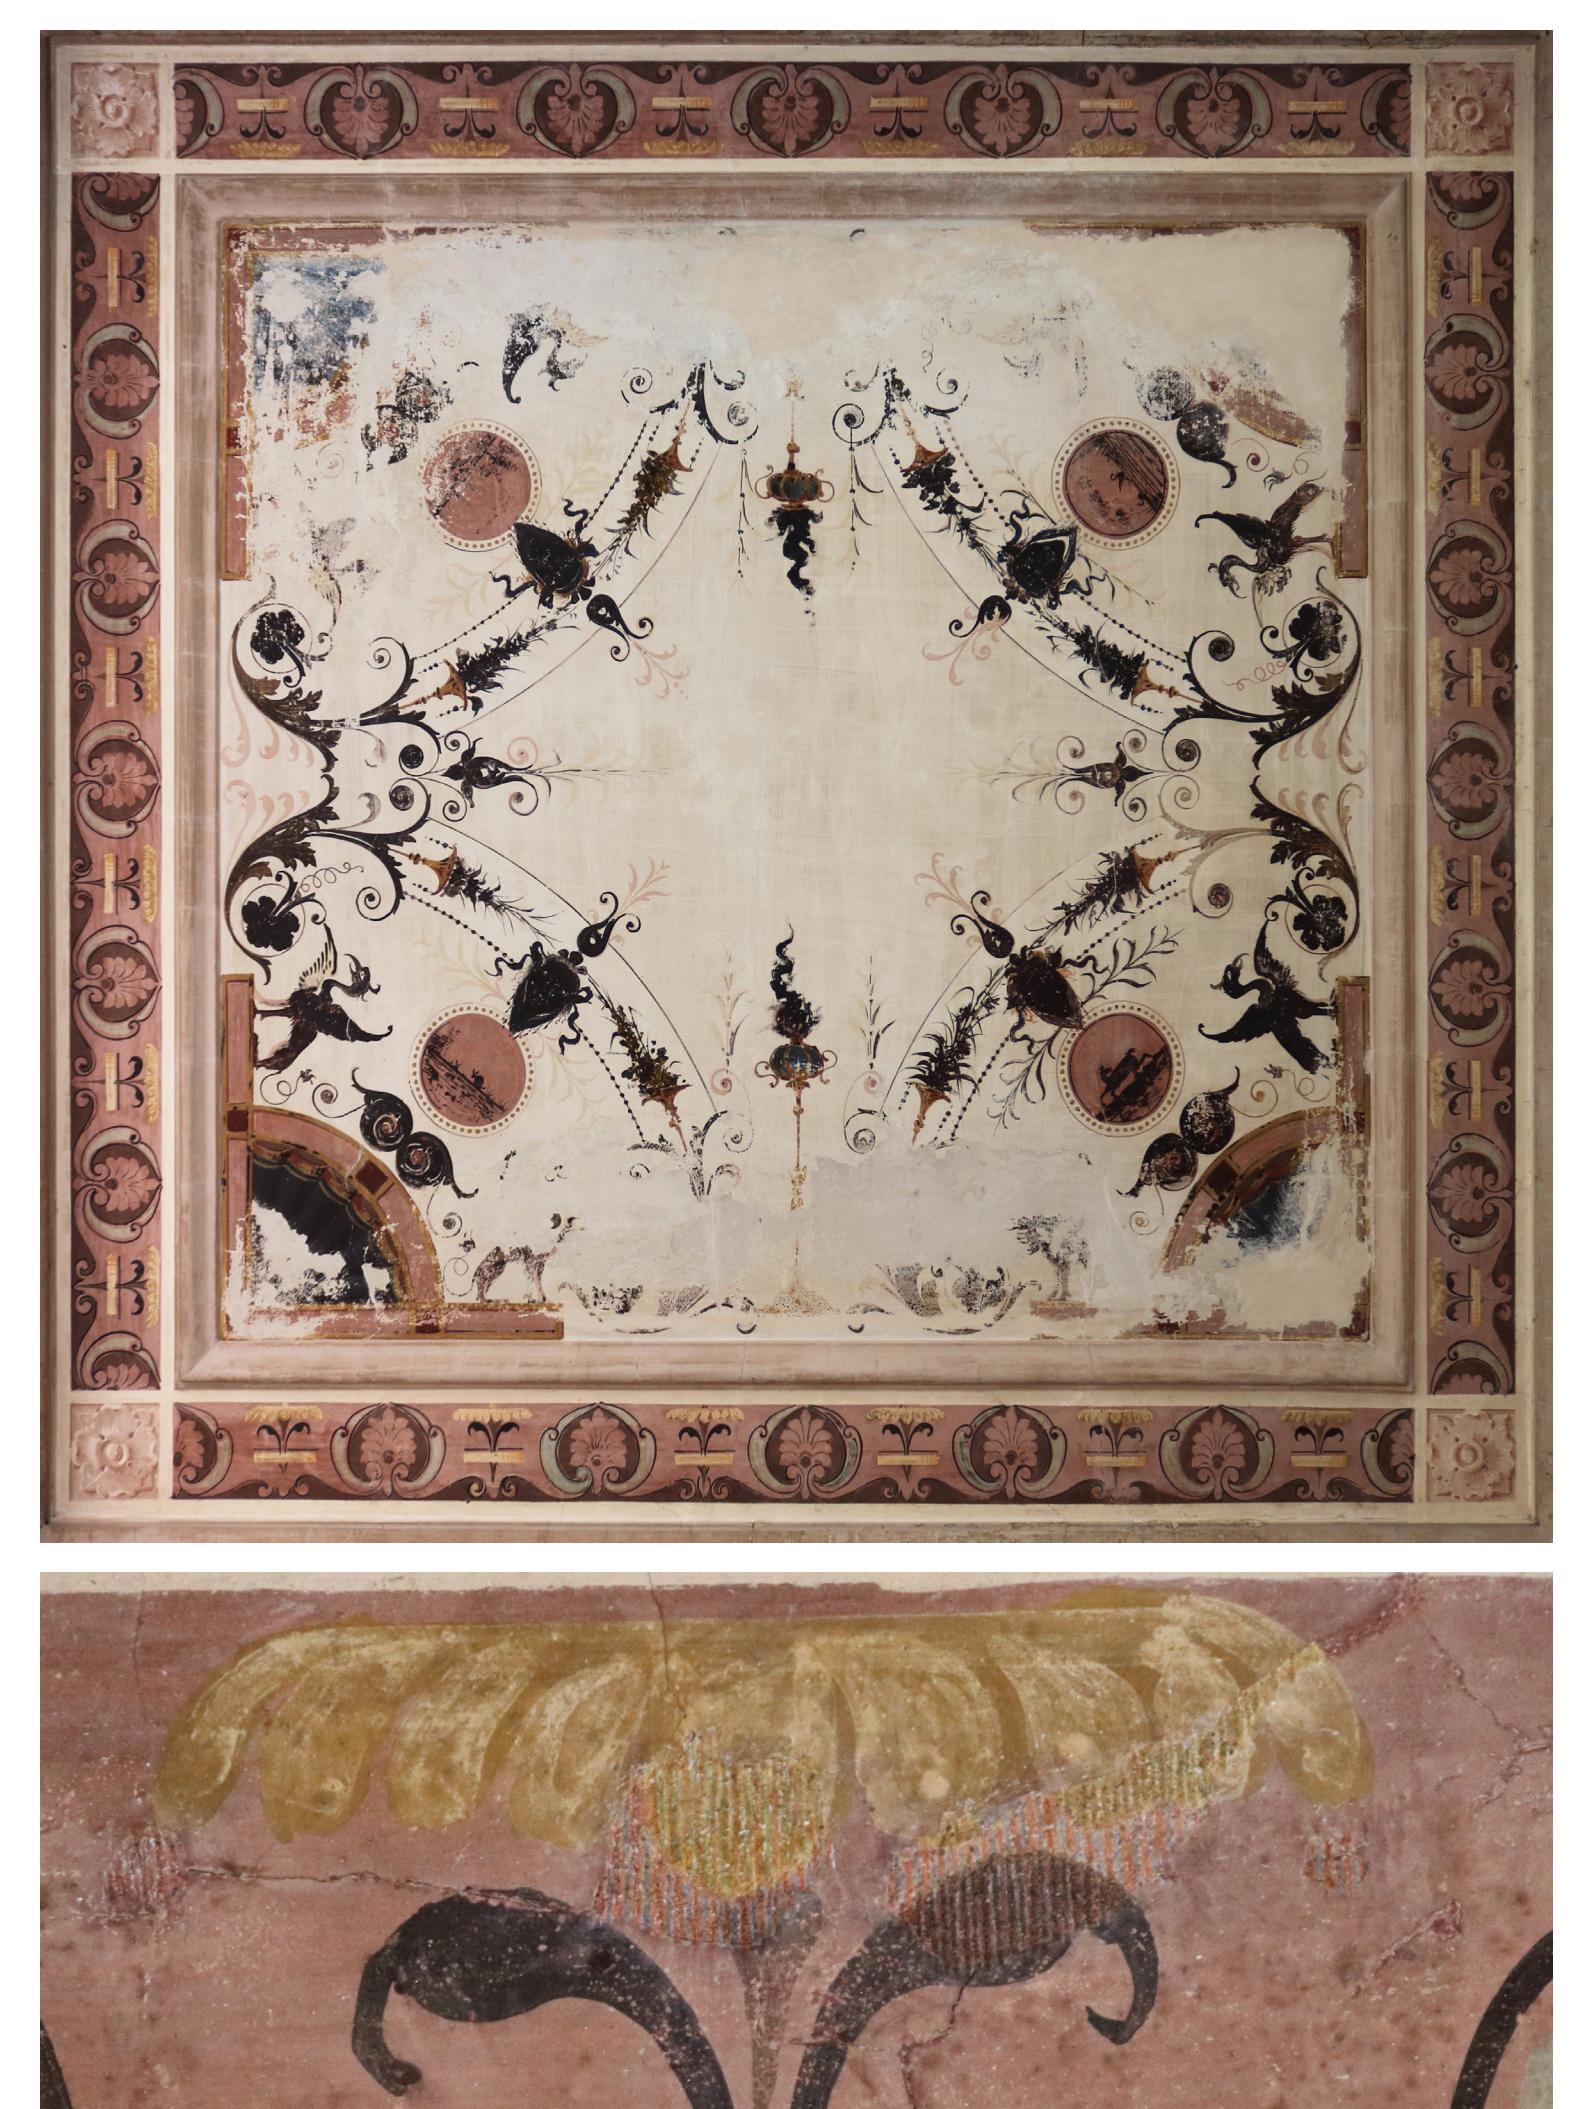
Fig. 2 : The Painting of the North Tower and detail after the interventions.

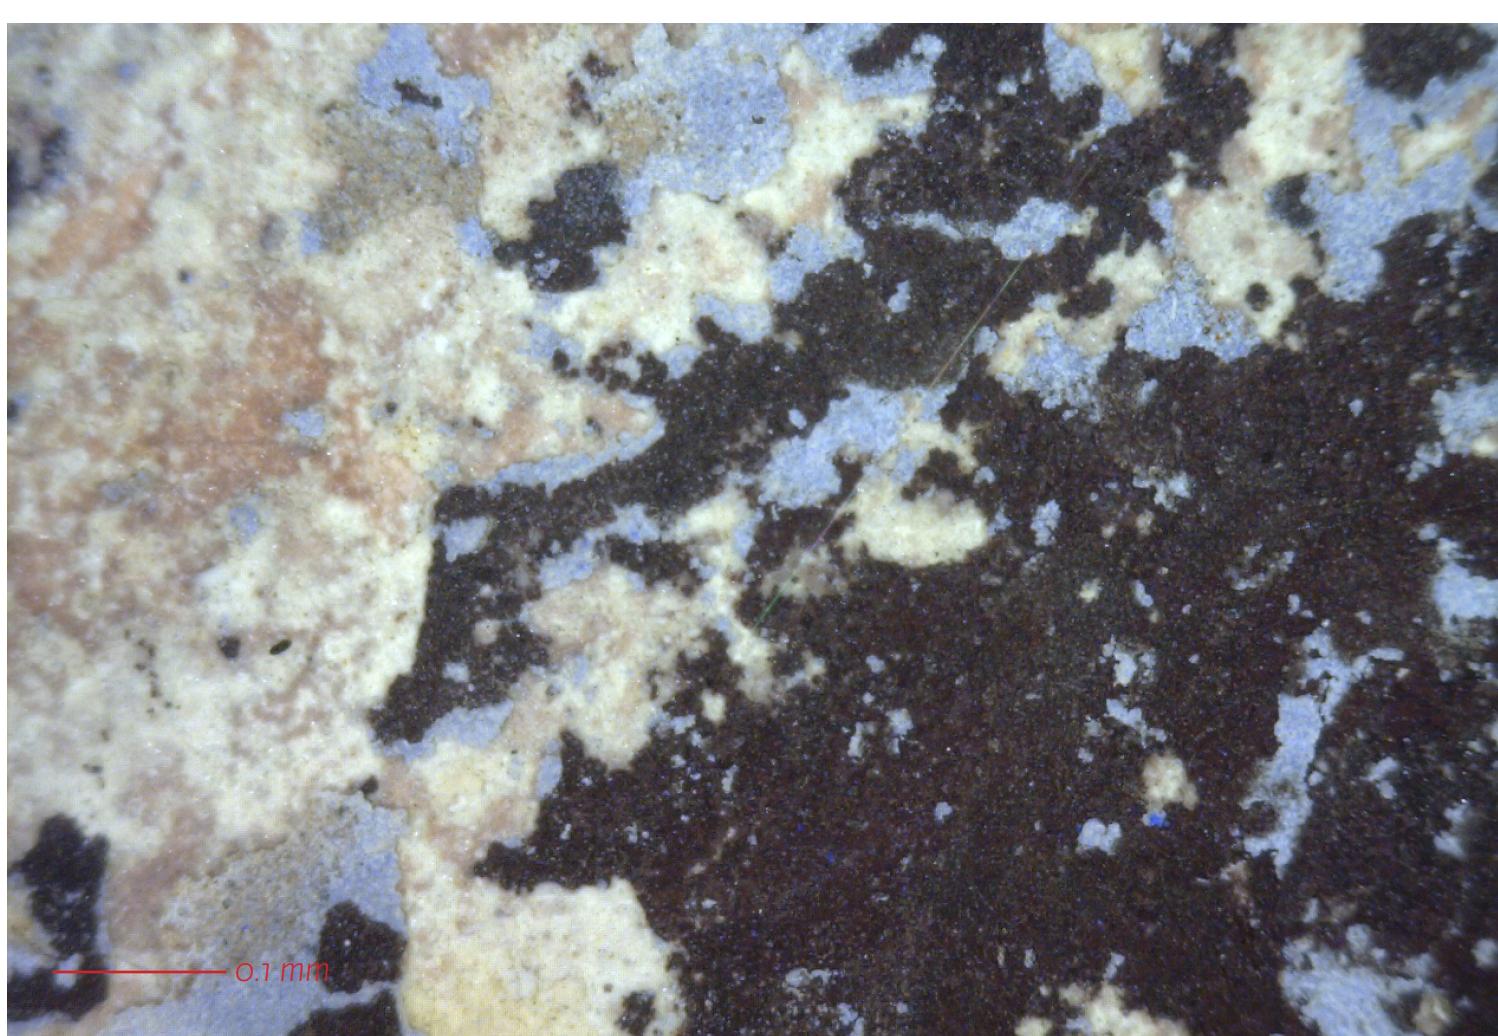
Fig. 4 : Detail of alteration of lead-based pigment. Portable microscope, 50x.

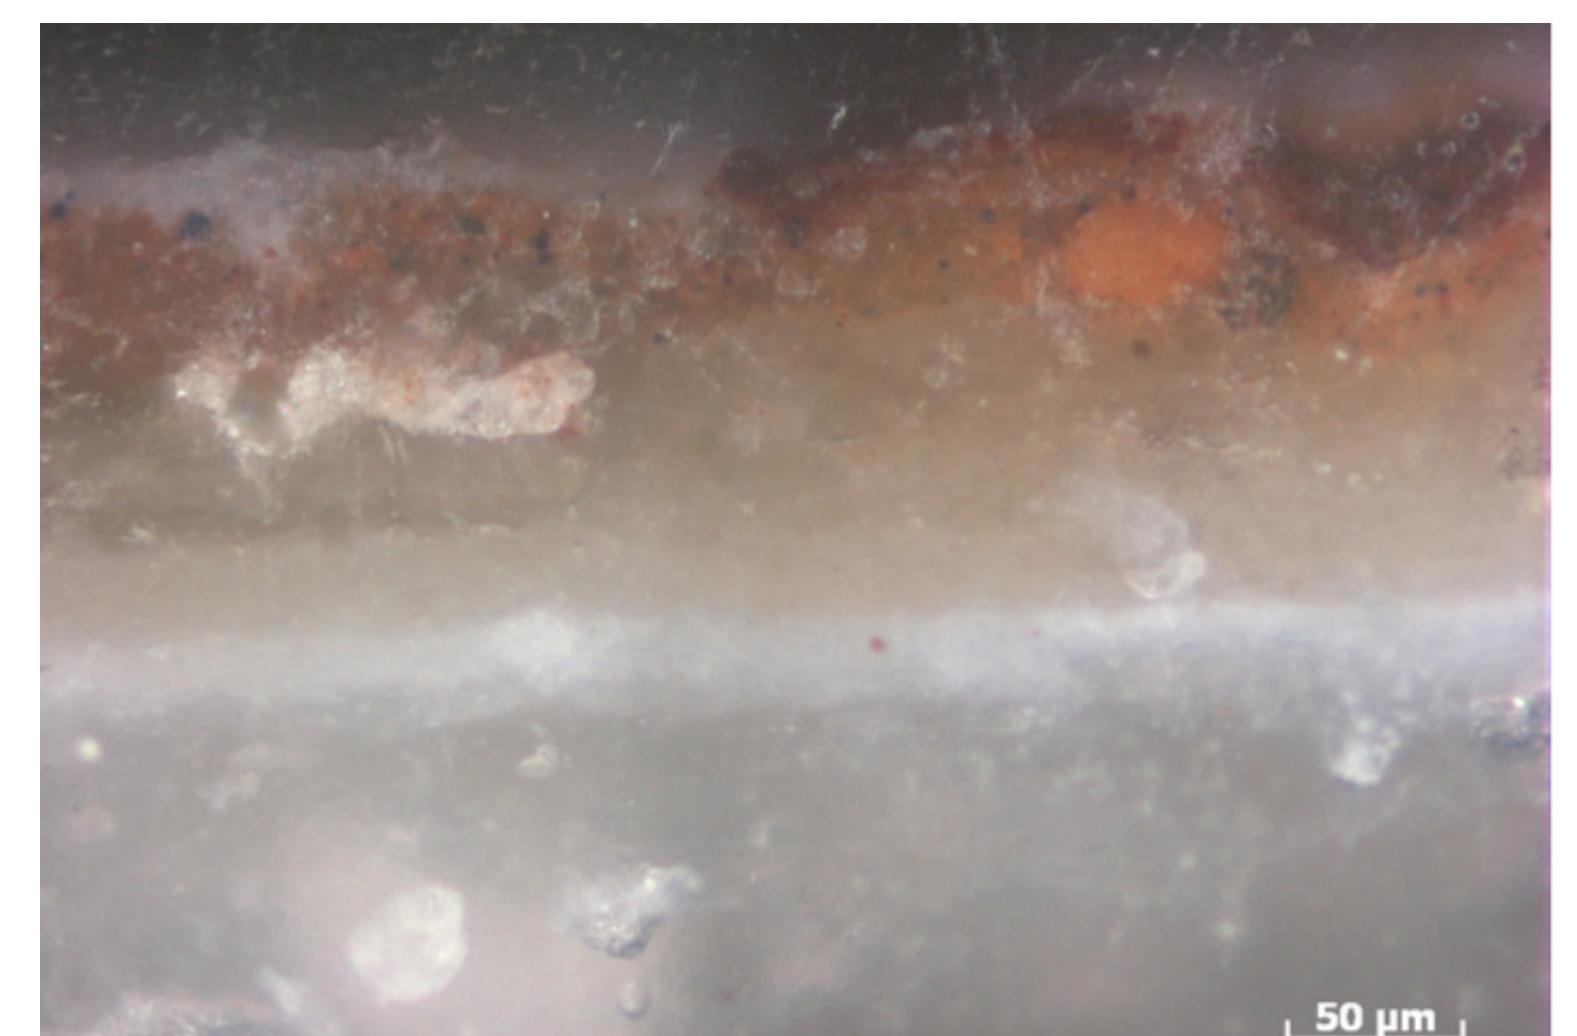
Fig. 5 : Microstratigraphic study of the altered paint layer. Cross section, PLM, 20x.

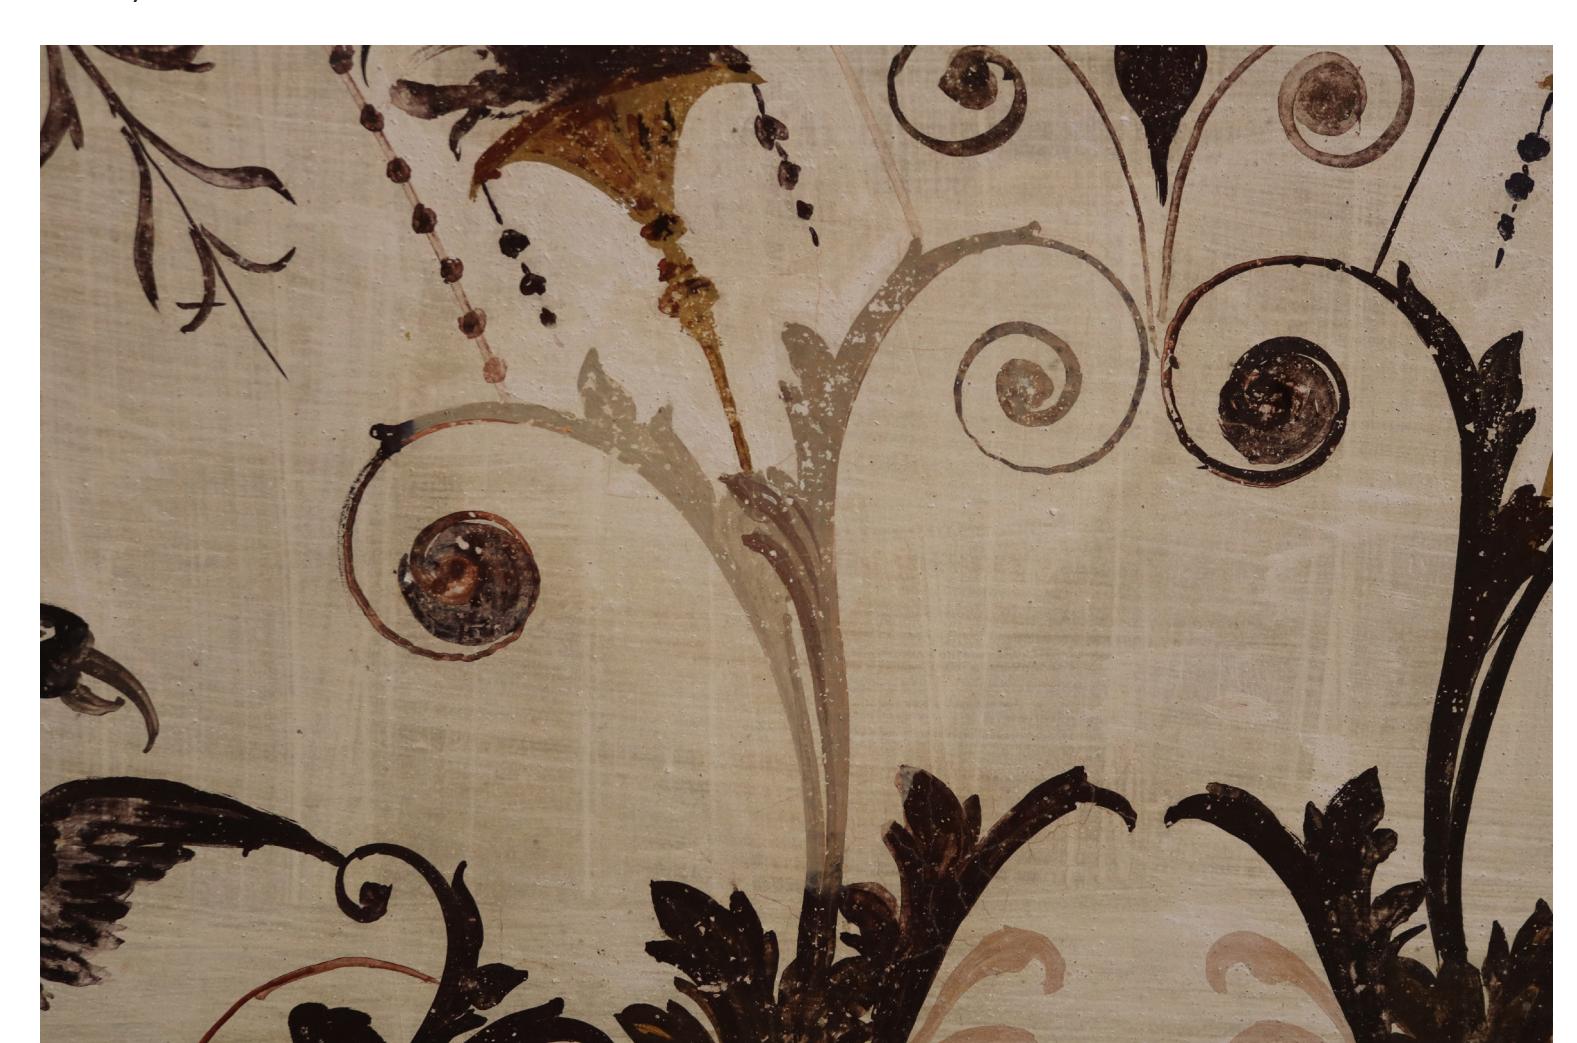
Fig. 8 : Detail of an altered area of the painting after the reconversion and stabilisation treatments.
